Project Data

Site: Defence Area 58: Avening World War II Defences
Parish: Avening
County: Gloucestershire

Survey Method: Measured earthwork survey

Date of survey: 07/12/2011 and 05/01/2012

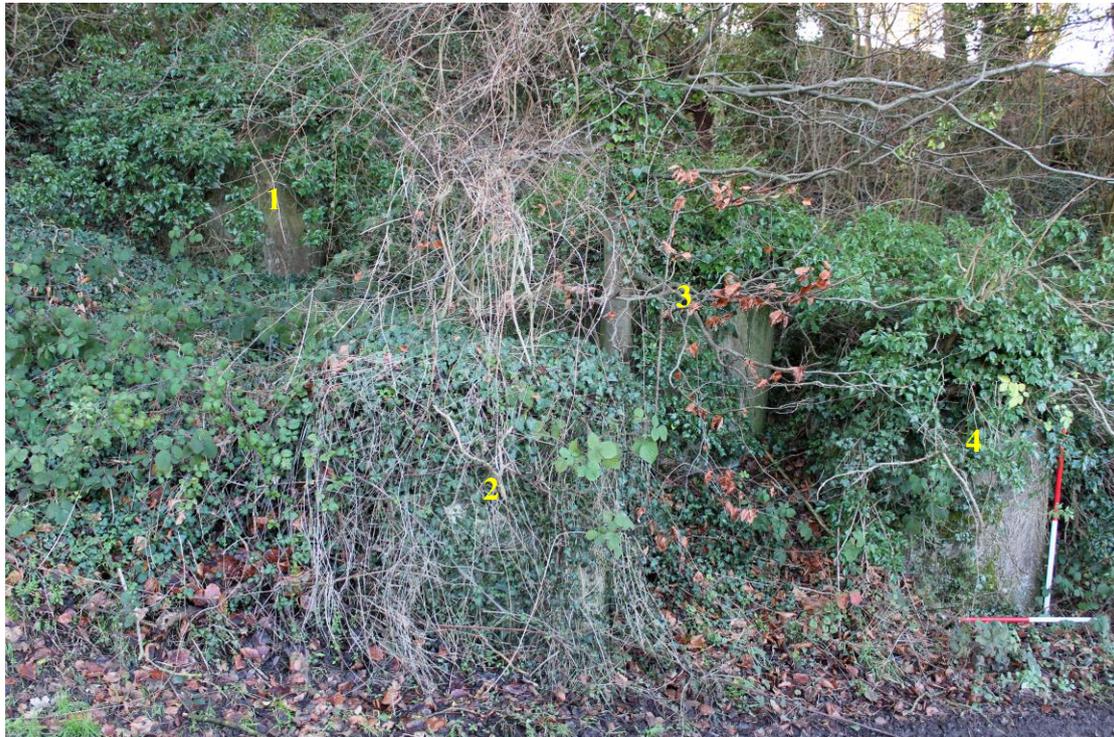
Figure 100 – Feature 1. Concrete Road Blocks x4, Star Lane.

Figure 100 shows the four (numbered) concrete cylinder road blocks which are situated on Star Lane, 70 meters down the lane from feature 2. Previous work on the defence line, shows only evidence for two of these road block cylinders in both the information from Gloucestershire Archive and in the Defence of Britain project, it is unclear why as all four have a similar amount of coverage from undergrowth. These are the only road blocks that have been found around Avening.

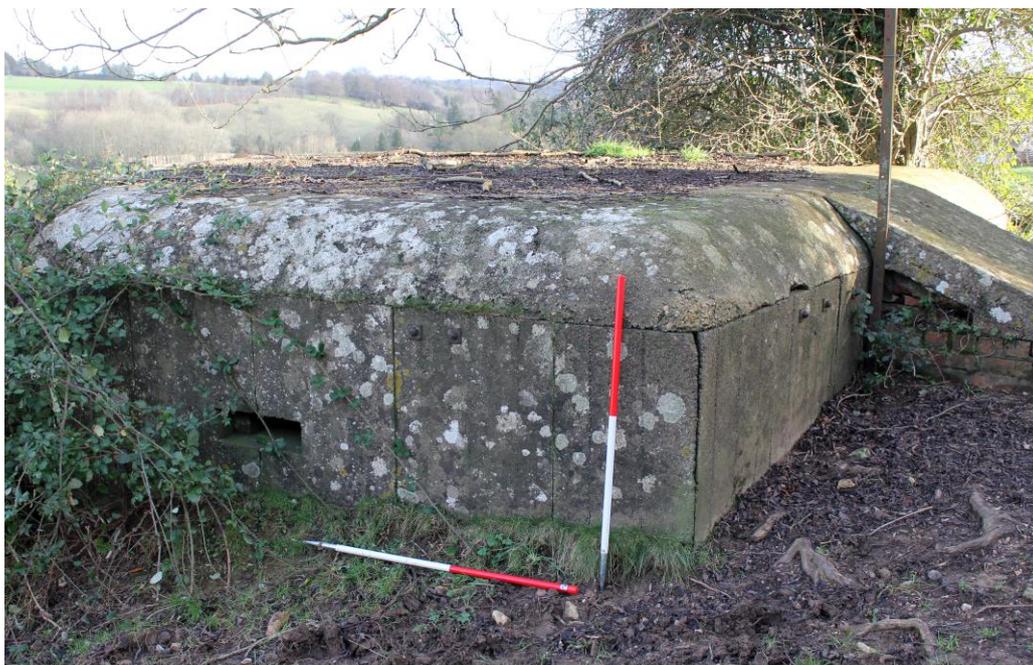
Figure 200 – Feature 2, Pill Box Type 24.
Photo taken from the south looking north.

Feature 2 is a Type 24 Pillbox. It is concrete-faced with prefabricated vertical concrete panelling fixed by iron bolts (figure 201). The roof has rounded edges which can clearly be seen on figure 200. It has an attached brick entry porch (figure 202) on the east side with a concrete slab roof. Due to cattle being in the same field, there is an eroded track around the semi-sunken in pill box where the cattle walk. Access into the pill box is limited due to the build up of soil in the entrance porch. Inside the pill box there is a build-up of rubble (figure 203) - it is not known where this has come from. Despite this, the inside of this pill box looks in relatively good condition. As it is entered, the facing wall is still intact (figure 204) and the internal prefabricated panels are still attached with their iron bolts. There is no public access to this pill box which has saved it from damage.

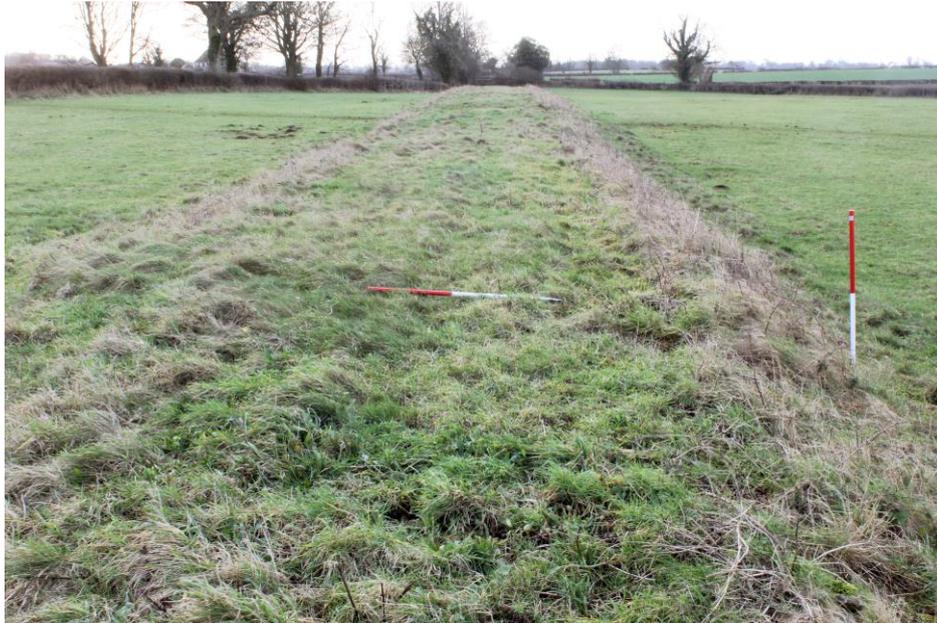
Figure 300 –Feature 3. Remains of anti-tank ditch.
Photo taken looking to the north east.

Feature 3 is the remains of the anti-tank ditch. Figure 300 shows the part of the remaining bank. It is not possible to take a photo of all of this section of the ditch due to its length, but figures 301, 302 & 303 indicate some of the sections. From looking at the drawing 502 of feature 5 it looks as though instead of this being the remains of the filled in ditch, stated in both the records from Gloucestershire Archives and the Deference of Britain report, it is the remains of the bank which would have once originally accompanied the ditch. As stated in 2.4, on AP 1 there is a linear line running parallel to this feature which again suggests that feature 3 is not the remains of the in filled ditch, but that of the bank.

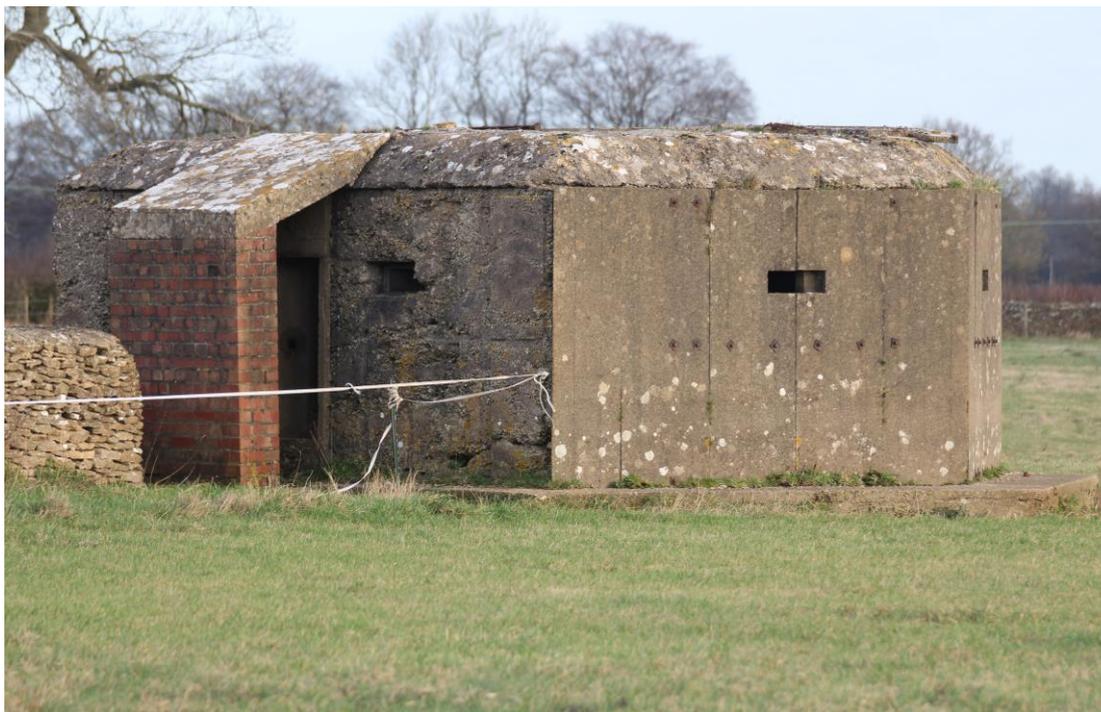
Figure 400 - Feature 4. Pill Box Type 24
Photo taken from the south west.

Feature 4 is a Type 24 pill box, it is located near Star Cottages on private land ownership, and is not accessible to the public. From figure 400 it is clear to see that it stands at full height. It has an attached brick entrance porch with a slab concrete roof. It is made up of prefabricated concrete panels secured by iron rods internally and externally which can be seen in figure 401. At first glance this pill box looks to be in a very good condition with a large number of the original concrete panels still in position. However, on closer inspection around the back of the pill box, the damage it has suffered is apparent. Figure 402 and 403 show that a large number of the concrete panels are missing – over time they have been used in the building of paths for Star Cottages, and for sewage pit covers. This information was given by the land owner. Internally there are calcium deposits forming stalagmites and stalactites from the leaking roof, and there is clear evidence that the pill box has been used by sheep for shelter, and other farmyard storage.

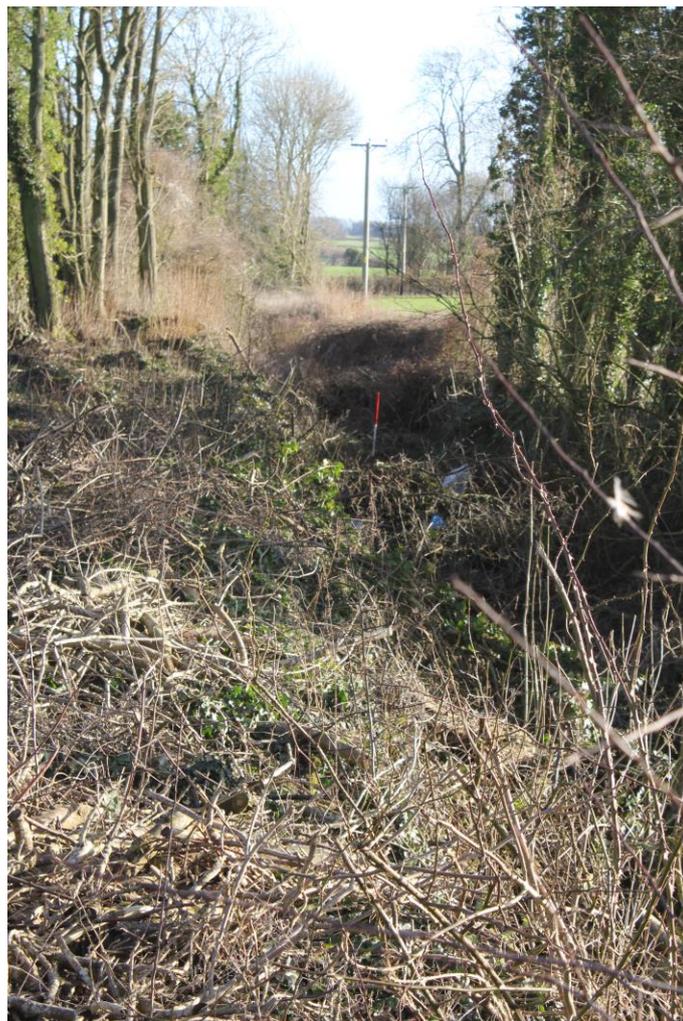
Figure 500 – Feature 5. Anti-tank ditch
Photo taken from the south west.

Feature 5 is part of the remaining anti-tank ditch that ran across the land joining up the pill boxes. This section of the ditch still remains unfilled. Figure 500 indicates some of the length of the ditch. Drawing 500 (first fold out) is the earthwork survey that was carried out. It is not the full length of the remaining ditch, as the dense surrounding woodland and built up rubbish (figure 501) in the ditch make it impossible to draw the whole distance. It is unclear why this particular section of the ditch remained unfilled, but from local knowledge, when it fell out of use, it was used for silage storage by Star Farm. It is now filling with rubbish and undergrowth. An entrance way has been cut into the ditch, point A on Drawing 500. This was built by the farmer to make it easier to dump rubbish in it. During and after World War II, the anti-tank ditches filled up with water due to a lack of drainage, and were used to teach the local children how to swim. Drawing 501 is a cross section of the anti-tank ditch. From this drawing it is clear to see that the ditch and accompanying bank can still be made out. Figure 502 shows the dry stone walls which can be traced along both sides of the anti-tank ditch.

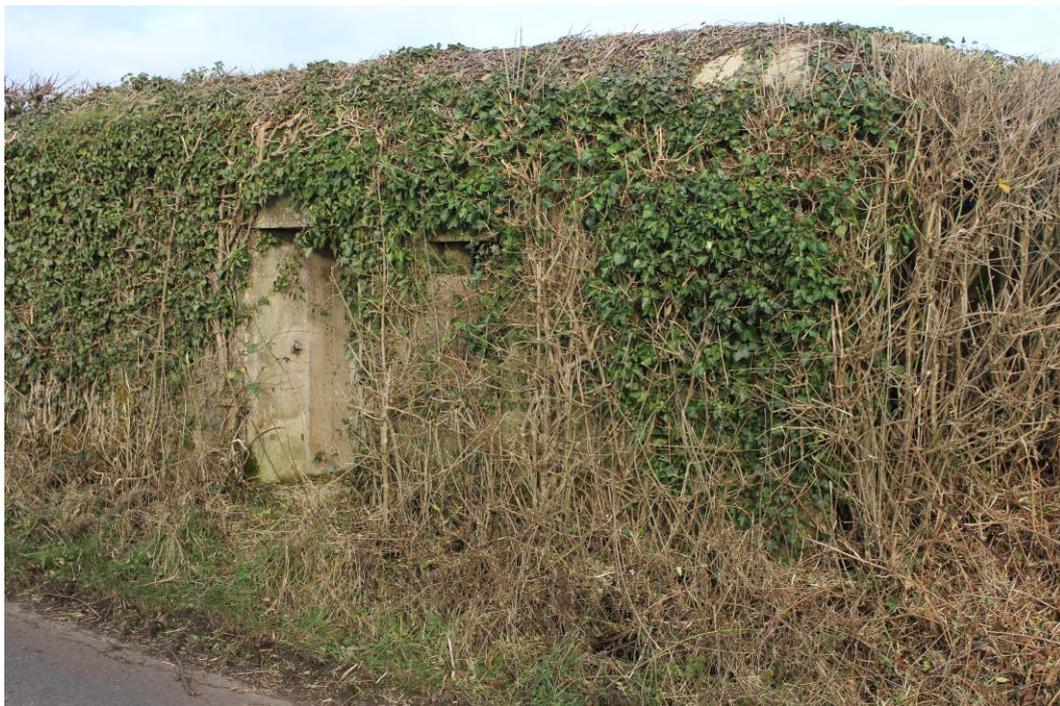
Figure 600 – Feature 6, Pill Box Type 24.
Photograph taken from the south east.

Feature 6 is a Type 24 Pill Box. This pill box is one and a half miles out of the village of Avening and is right up against the edge of the unnamed lane that goes towards to Tetbury. It appears to have been built into the hedgerow of the field, which can be clearly seen in figure 600. It is semi-sunken and in very good condition. It is made up of prefabricated concrete panels bolted together with iron bolts both externally and internally (figure 601). Internally this pill box is in the best condition compared to the others of the same section of GHQ Line Green defence. It has had some modern additions including the application of paint, some polystyrene roof tiles, and a mattress (fig 602). It has obviously been used as someone's home – probably a vagrant. This pill box does not have an entrance porch like others and not such a clear view out of the windows but this may be due to growth of surrounding woodland and the sinking that has occurred.

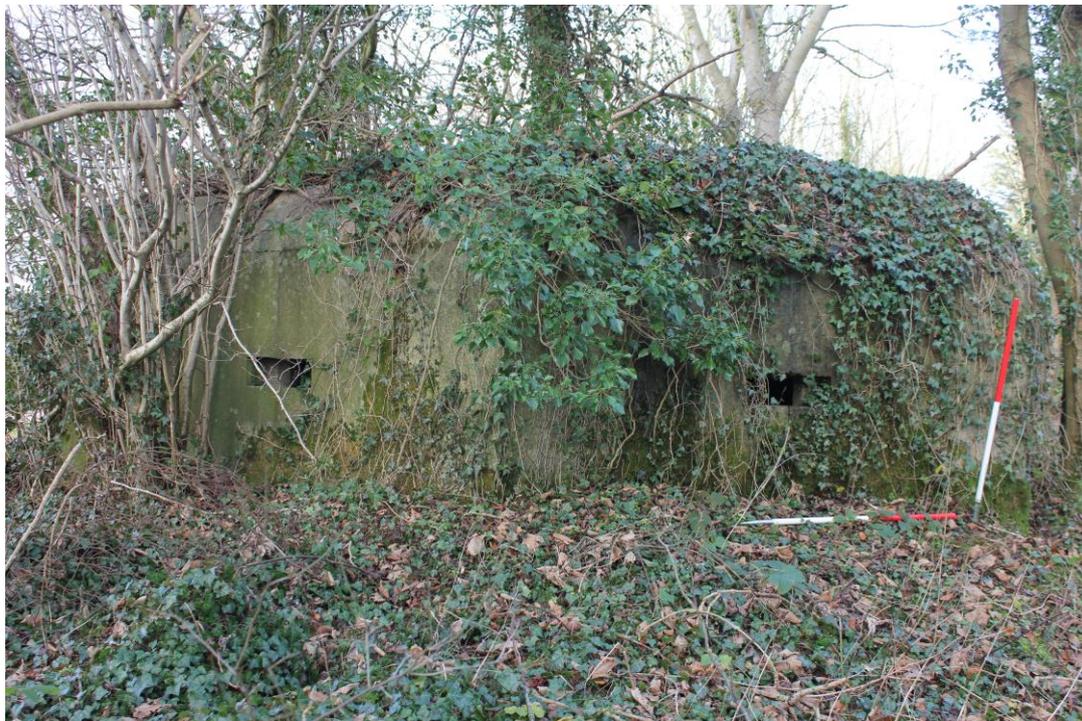
Figure 700 – Feature 7 – Pill Box Type 24.
Photo taken from the south looking north

Feature 7 is a pill box. It would have originally have been joined up feature 6 but an anti-tank ditch and bank. There is some evidence for the remains on AP 6 of

this but most of it has been destroyed by ploughing. This pill box is made up of prefabricated concrete panels which are held together by iron bolts. There is a considerable amount of undergrowth surrounding the exterior pill box. The interior is in good condition as the entrance was blocked up but has recently been opened. The entrance wall is still standing and the attached entrance porch is in good condition (figure 701).

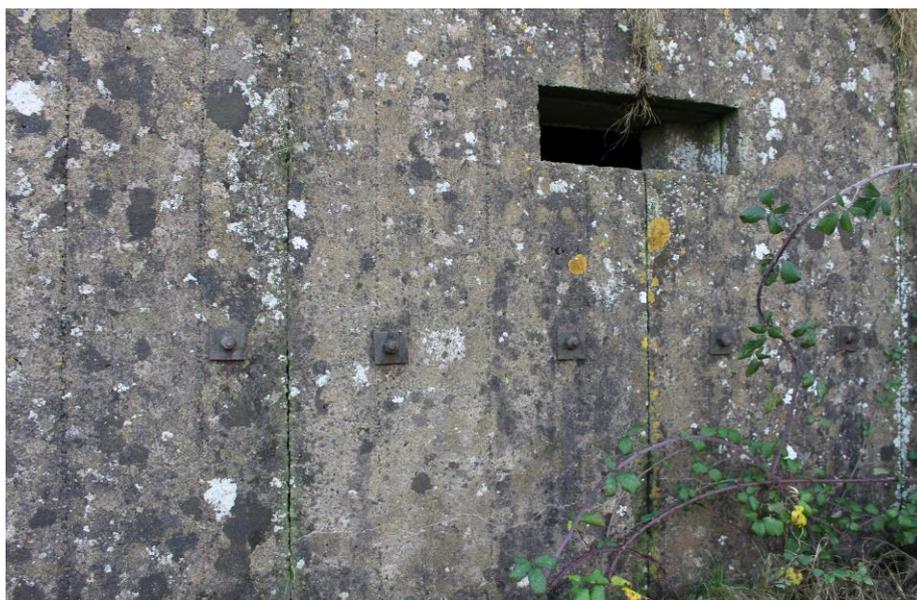
Figure 201 – prefabricated concrete panels and iron bolts

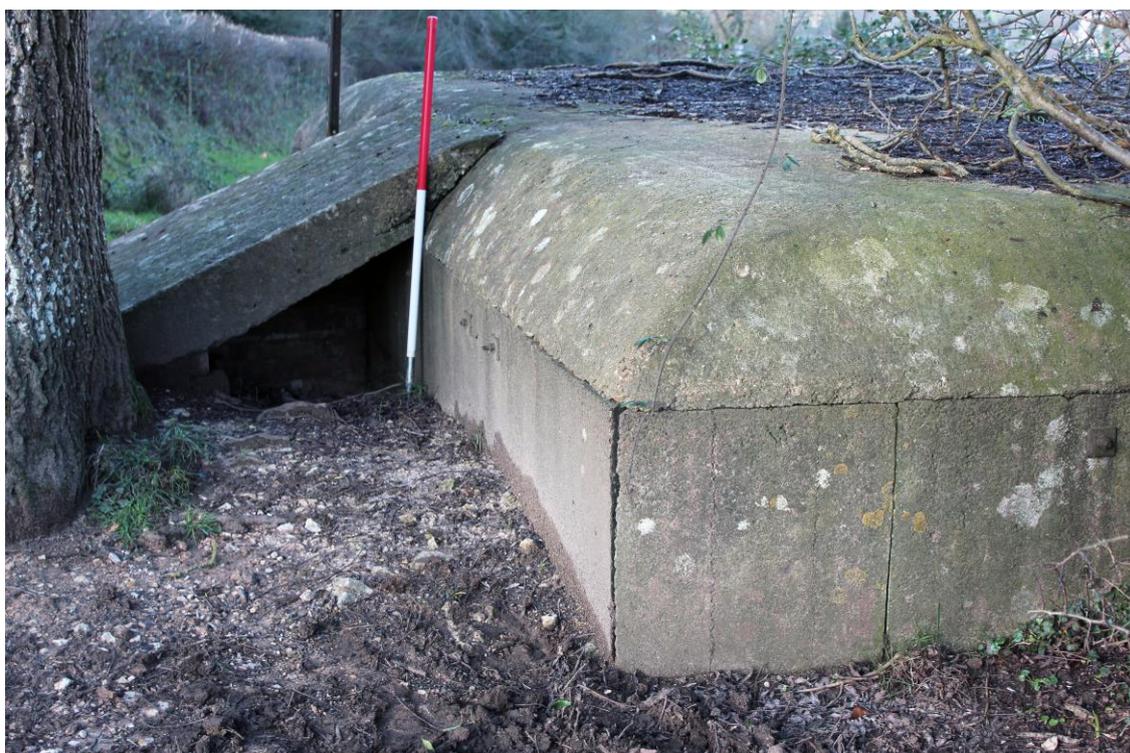
Figure 202 – Entry porch to the pill box, semi-sunken by soil

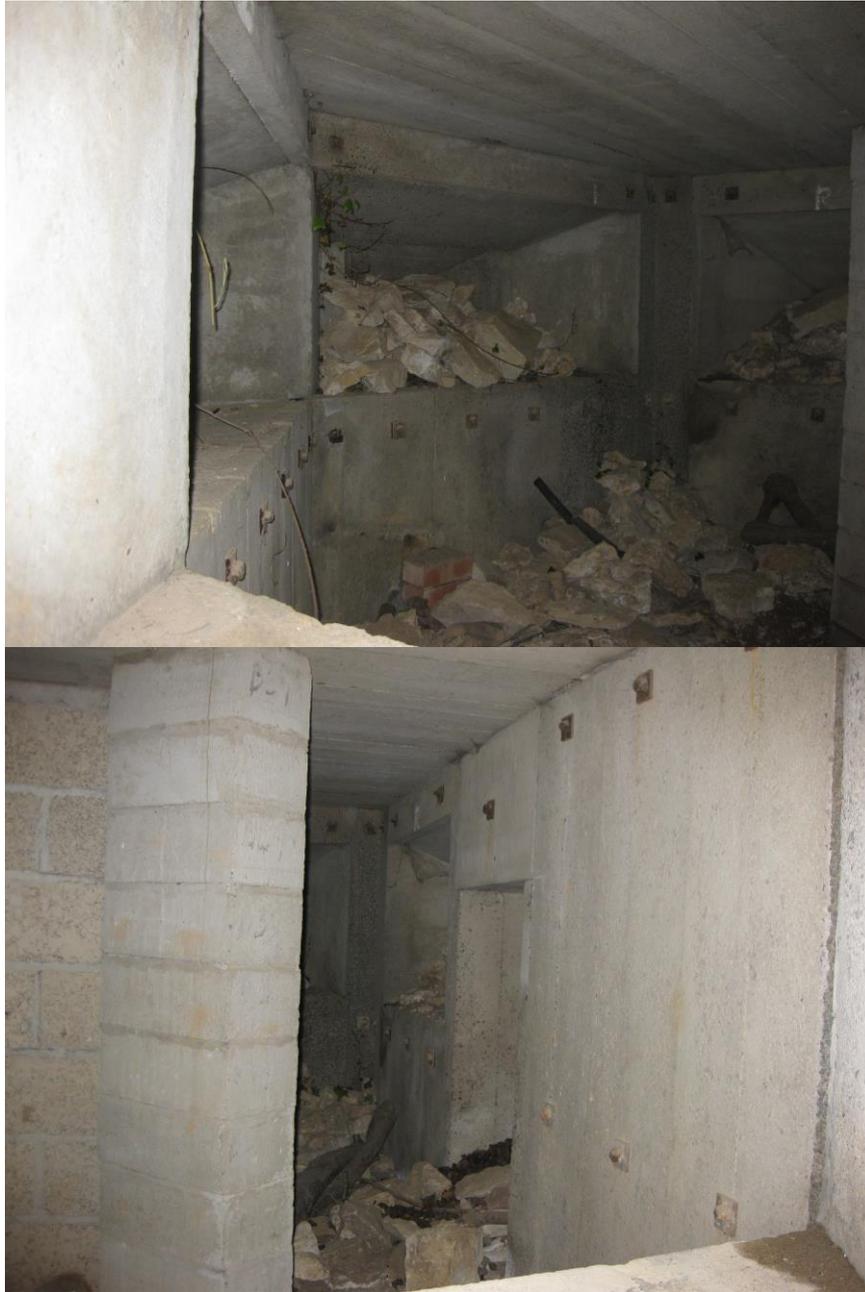
Figure 203 – Rubble starting to build up in the pill box.

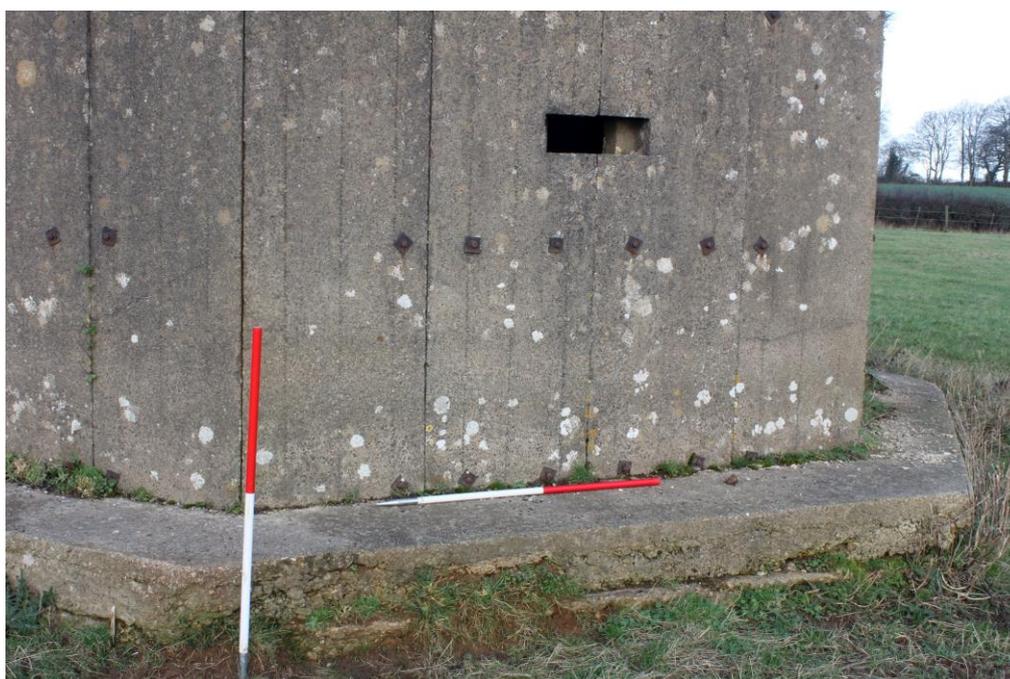
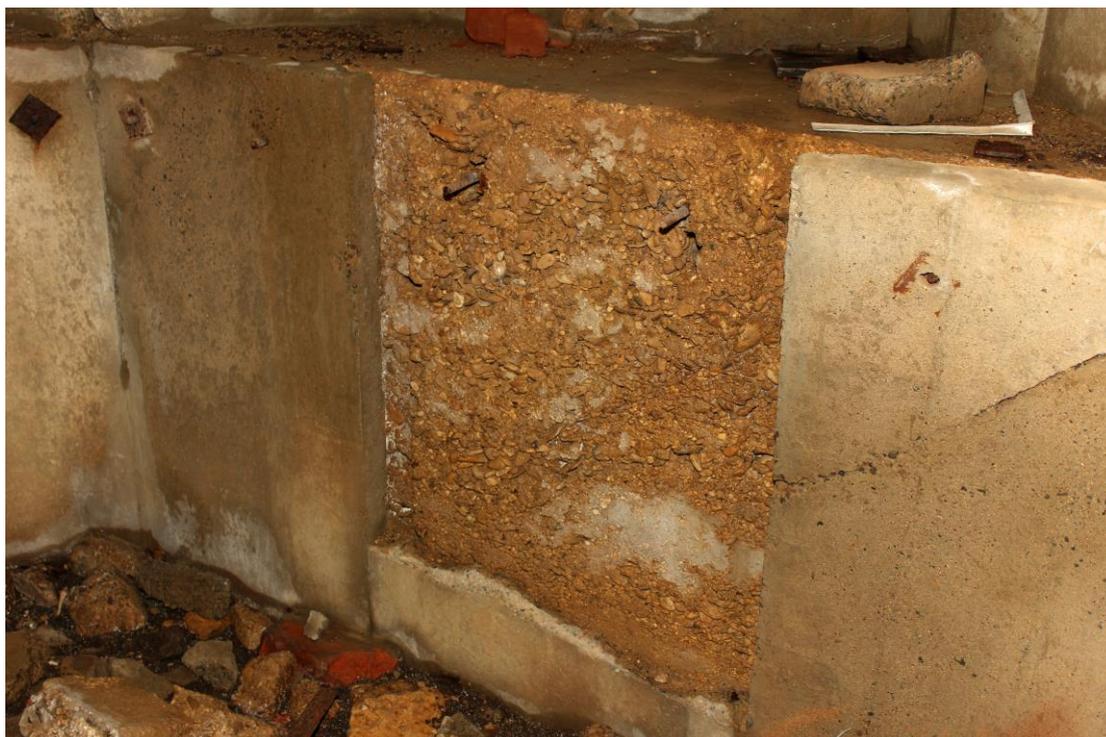
Figure 402 – photo showing some of the damage what has occurred to feature 4.

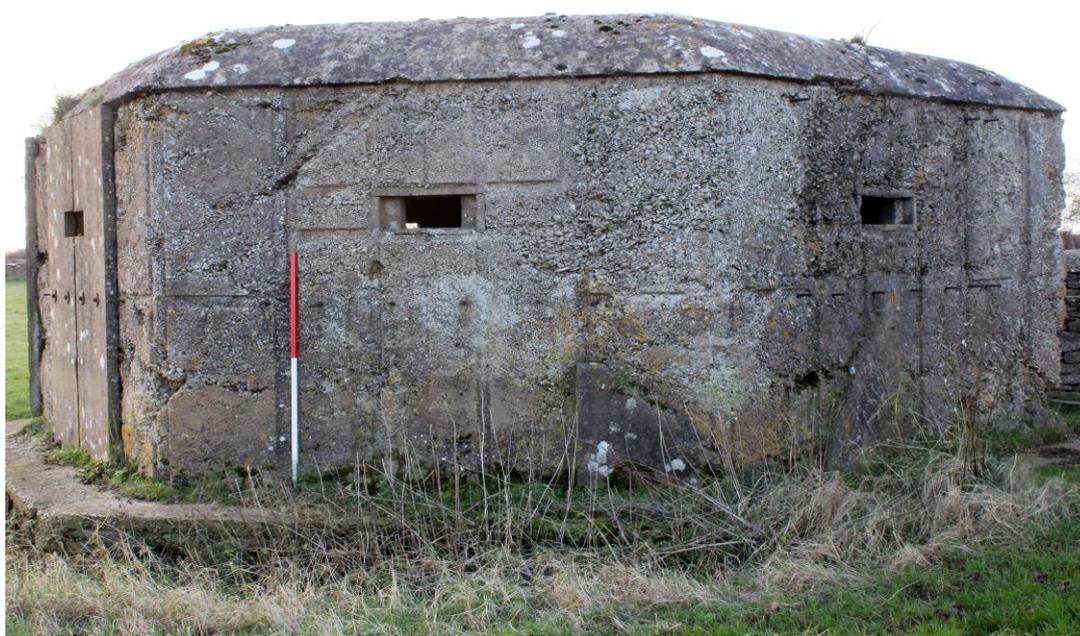
Figure 403 – photo indicating the damage to the outside of feature 4 which is not visible from Star Lane (photo taken looking towards the lane)

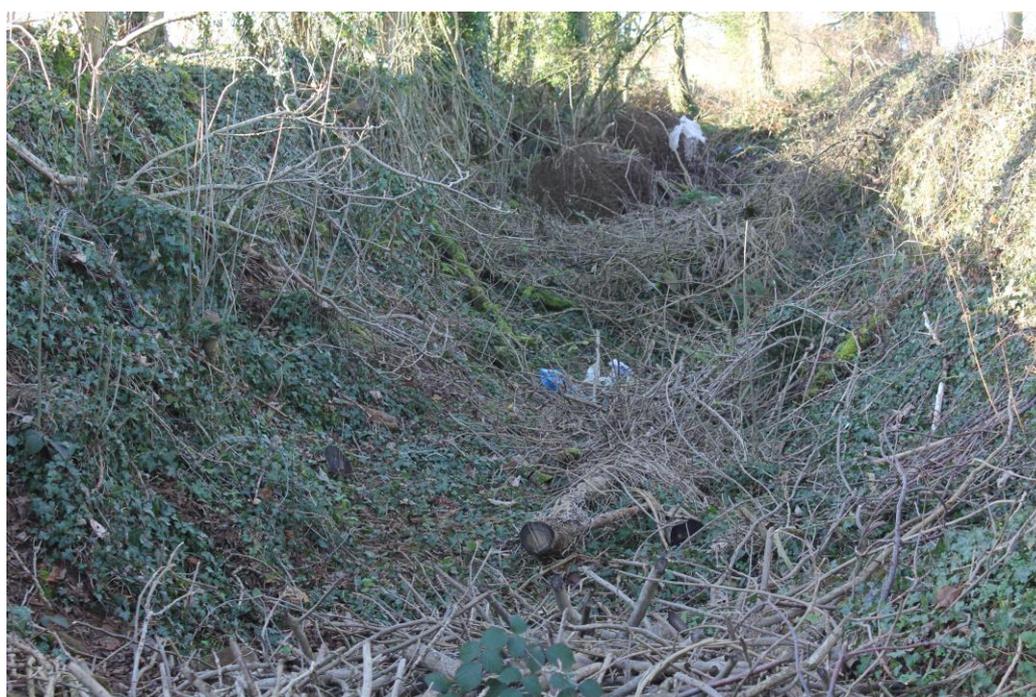
Figure 501 – photo indicating the build up of rubbish in the anti-tank ditch, feature 5

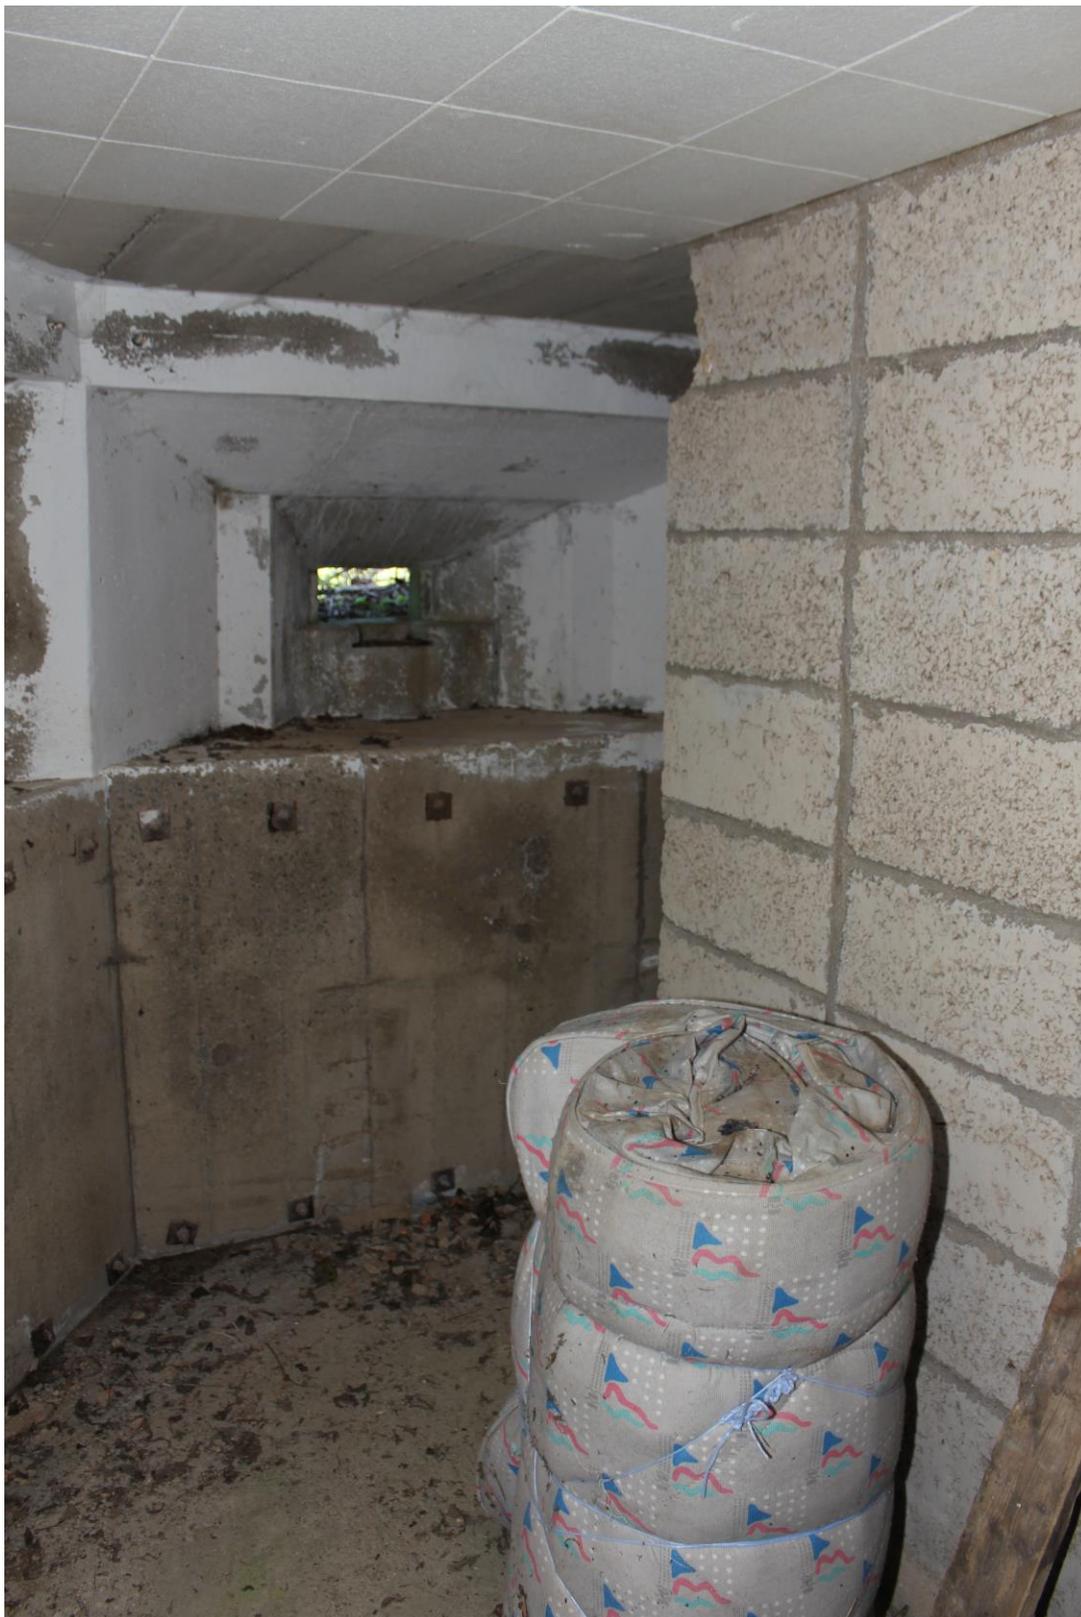
Figure 602 – photo indicating modern additions including a mattress, paint on the walls and polystyrene roof panels

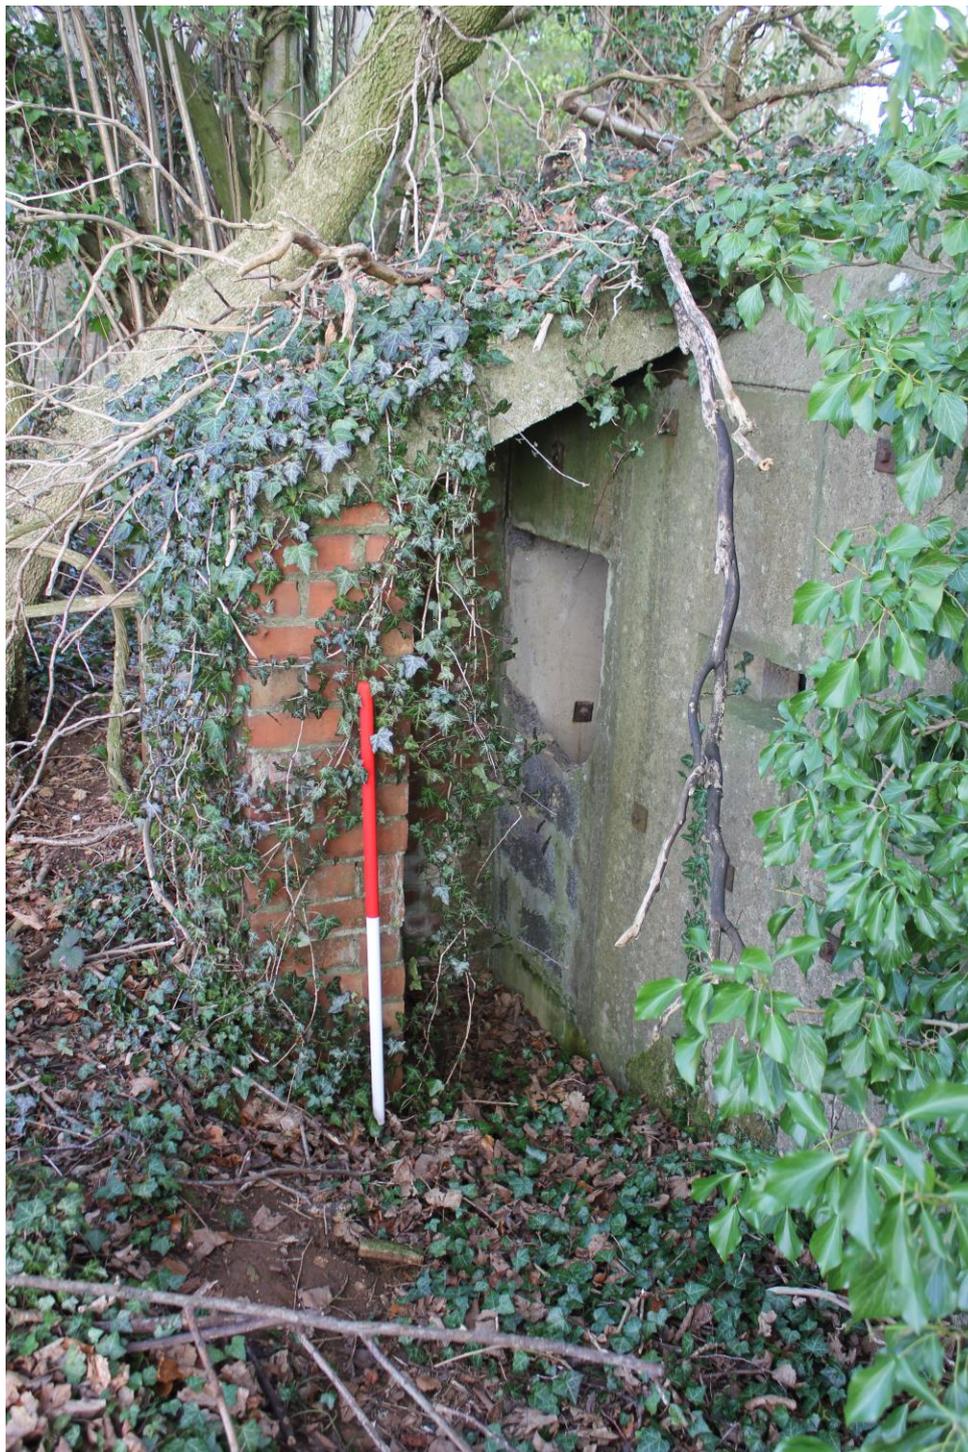
Figure 701 – entrance porch of feature 7
