Standing Building Report

Holy Cross Church
Avening

Survey Method: Photographic survey
Date of Survey: Drawn January 2008, updated April 2012
Survey team: Emma Slater
Georgina Mansell
Photographs: Antony Slater – Slater4Ltd.

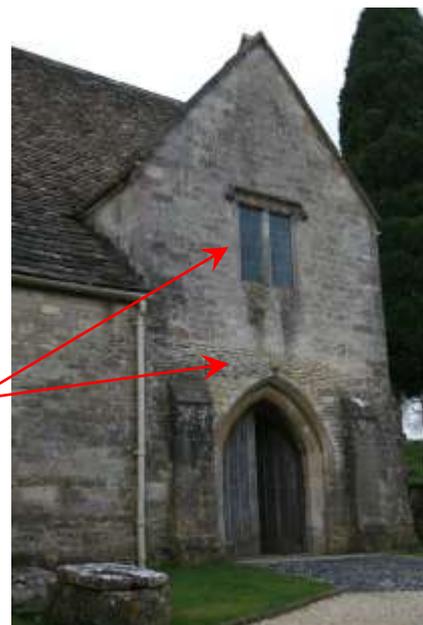
Fig 312 - North porch.
Decorated doorway set in rubble walling; upper porch freestone with Tudor window - C 16th

These are the results from a detailed photographic study of Holy Cross. Starting at the entrance porch; this was added as a school house in the C 16th. It is clearly identifiable as the Tudor period because of the square window (fig 312). It was used as a small museum in 1972.

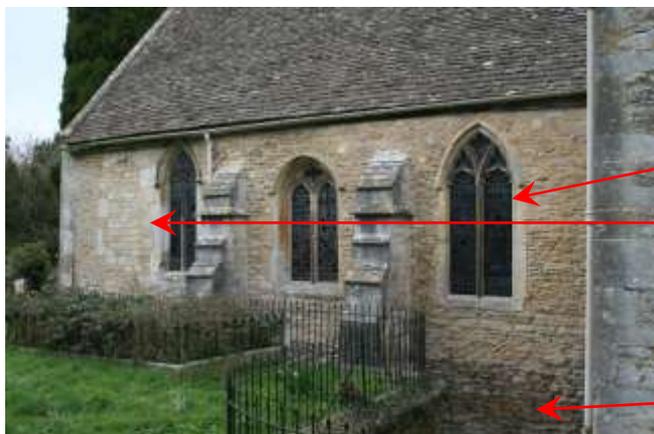
Fig 301 - south wall of the nave. Buttresses to support south wall. 3 Decorated Gothic windows early C 14th. Blocked window at west end, possible external entrance to 19th C gallery. The stonework is freestone coursing especially below eastern most window. Darker stone suggests it was level below ground until C20th.

As well as the filled in door, there is also dating evidence in the windows. There are 3 Decorated Gothic windows which date to the early C14th (figure 301, 303

& 306); the middle window is later than the other two. The stonework is freestone coursing, especially below the eastern most window. The darker stone suggests that it was below ground until C20th (fig 301) when the trench around the church was deepened.

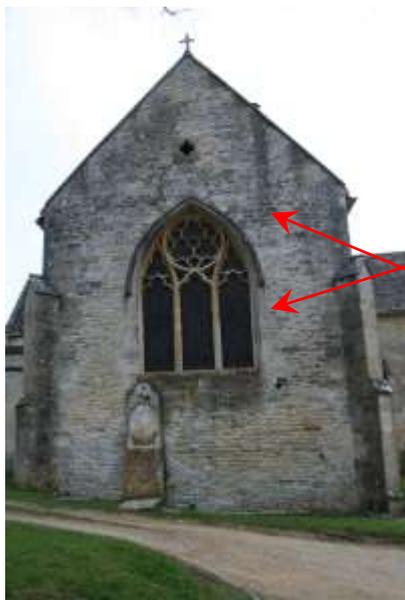
Fig 307 - East gable end of gable with Decorated Gothic window. More regular building layer at top to better support the roof.

On the eastern end of the church, the window is a decorated gothic shape dating from C 14th (fig 311). This can be identified by the original carvings and the stops (fig 307). When measuring this side of the church you can see that the floor level outside is different to that of the inside. Talking to people and looking in the inside, I think that it would have been used as a grave. There are grave stones set into the floor on the inside, which would clarify this because there are no burials outside of the church before the 1700's.

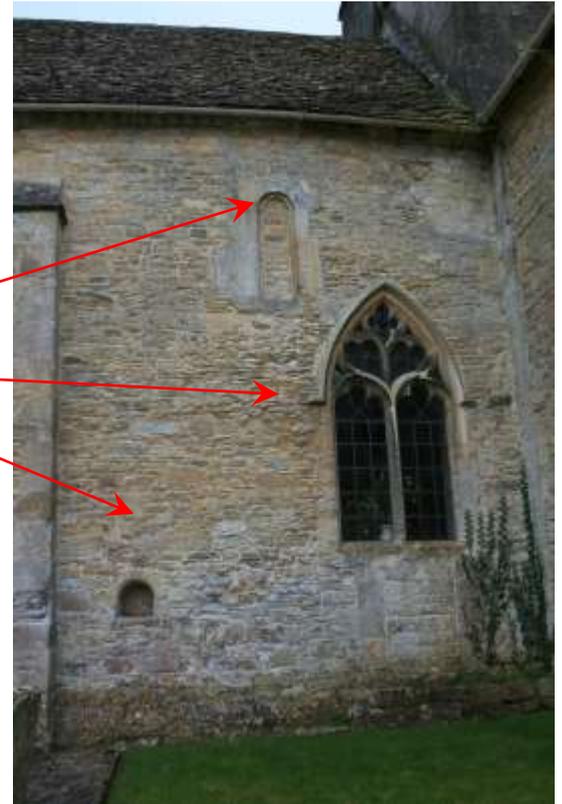
Fig 309 - decorated Gothic window;
small blocked Norman window above
12th C; piscina below. If not
repositioned suggesting lost north
chapel. More evidence of building lift

On the north side of the Chancel there is some evidence that in the early C 13th a small chapel existed, perhaps a Lady chapel. The evidence is the door jams which are very visible and there is also a 'step' which would have been used to enter the chapel, as the floor level would have been lower than that of the other parts of the church (Fig309). There is also a piscine which still exists outside the northern wall of the chancel; the eastern foundations of this chapel can still be traced. Some tiles and other relics were found on the spot, and a piece of molten metal, from which it is inferred that the chapel was possibly destroyed by fire (Playne 1978:91). There is a possible door in the Chancel which may have once lead into the Lady Chapel (figure 330). Just above the evidence for the extra chapel there is a blocked in Norman window. This can be identified by its shape - it has an oval curve at the top, and the outside of the window is much smaller than the inside because they did not have glass. The windows were small on the outside and panned out inside to let more light in (fig 309 and fig 325). There is also clear evidence of lifts, each between 1½ - 2 ft which are finished off with the bigger stones (fig 308 & 310)

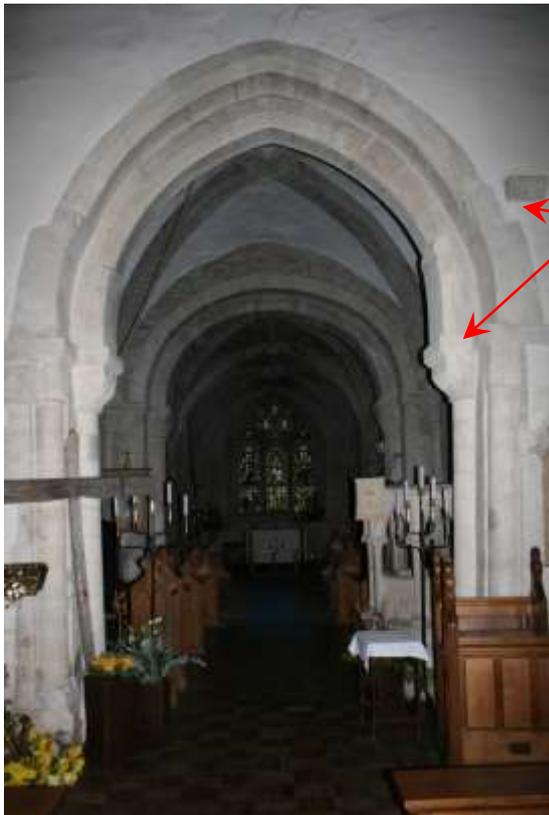
Fig 328 - East wall of naïve into tower. Norman archway with decorated capitals; upper section rebuilt in early English style

On the East wall of the nave into the tower there is a Norman archway with decorated capitals; the upper section was rebuilt in early English style (Fig 328 & 326). This also shows the social changes. Removing the top of the rounded Norman arch and replacing it with a pointed English style top was more fashionable at the time, but because only one of the arches was reshaped, this may not have been considered successful; otherwise they would have changed the other arches in the same way. Possibly it was a financial issue? Just beyond that on the south wall of the tower the original Norman window still exists, this can be seen in figure 327. The Norman aisle arcade can again still be seen on the north face of the nave (figure 331).

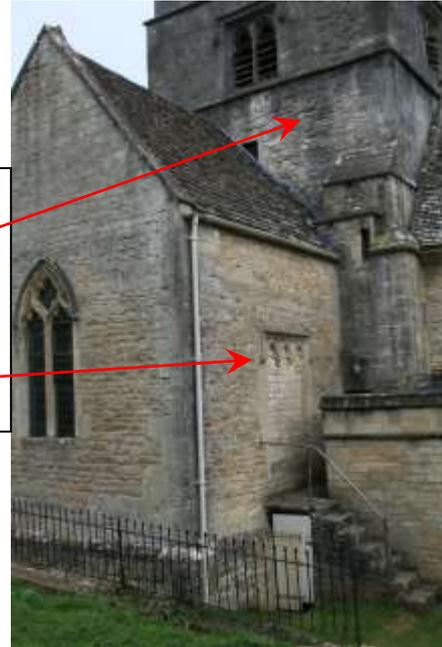
Fig 299 - South transept exterior – Rubble main wall, free stone roof gable = roof later build. note blocked perpendicular window late C15th.

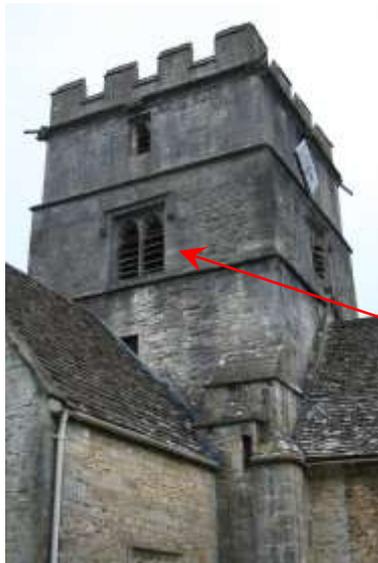
Fig 300 – South side of tower. Free stone top layer with crenellations above. Middle storey part rubble, part free stone with late perpendicular/Tudor bell openings. Lower level rubble built. Demonstrates top 1 ½ storeys rebuilt probably in late 15th/early 16th C. Blocked window in lower stage of tower shows south transept built later. South wall of naïve shows butting joint between 13th C nave stonework & 12th C tower stonework.

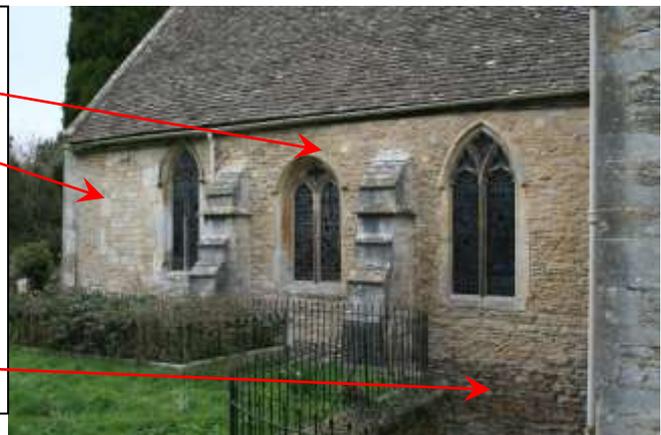
Fig 301 – south wall of the nave. Buttresses to support south wall. 3 Decorated Gothic windows (early C14th). Note blocked window at west end (see internal photo) (possible external entrance to 19th C gallery). Note stonework – freestone coursing especially below eastern most window. Darker stone suggests it was level below ground until C20th.

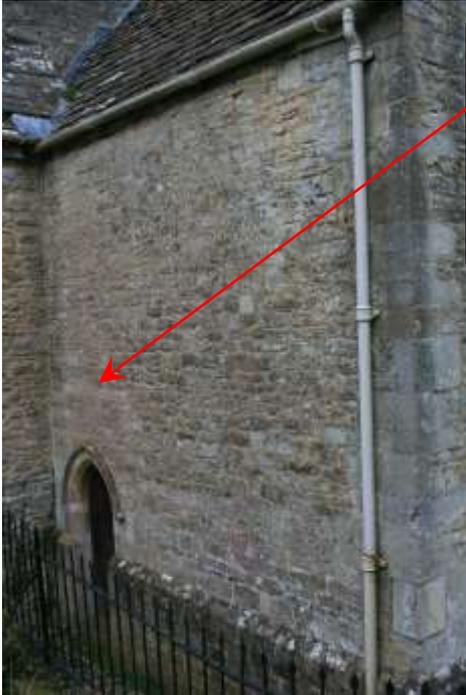
Fig 302 – West wall of south transept. Note squared stone in lower courses and over door suggesting 19th C restoration. Door frame C19th .

On the west wall of south transept there is clear evidence for it being partly rebuilt - this shown in fig 302. On the same transept, again in the restoration, you can see that they have used the same stones from both this part of the church and others. In fig 3442 you can see the blocked-in perpendicular window. Opposite this window is the newest part of the church, the vestry. Around it you can clearly see how this side of the church looked before the vestry was added. The exact date is not known, but with reference to the plans which were produced in 1827-1829 (plan 200 and plan 201) you can see that it was already there.

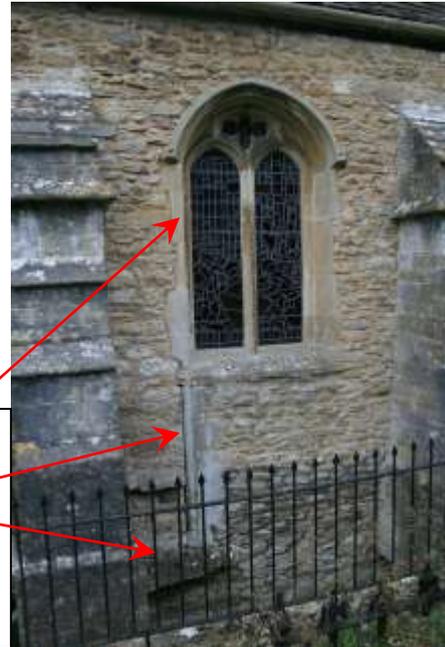
Fig 303 – Decorated Gothic window restored in 19th C. Note door post column below window (no other evidence of door). Bedded on a large protruding stone block (doorstep?).

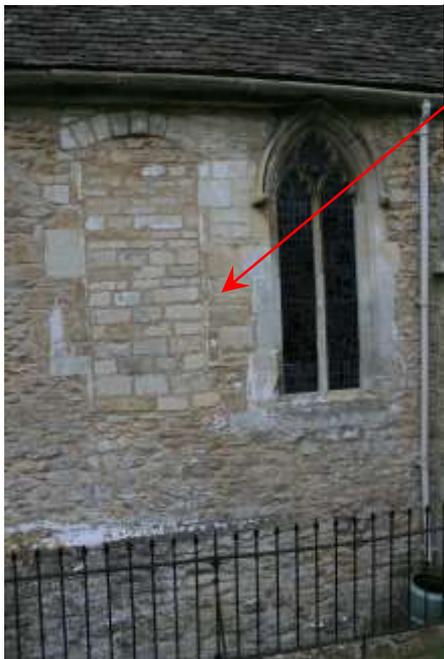
Fig 304 – detail of 19th C blocked window/balcony entrance on the south wall of the nave.

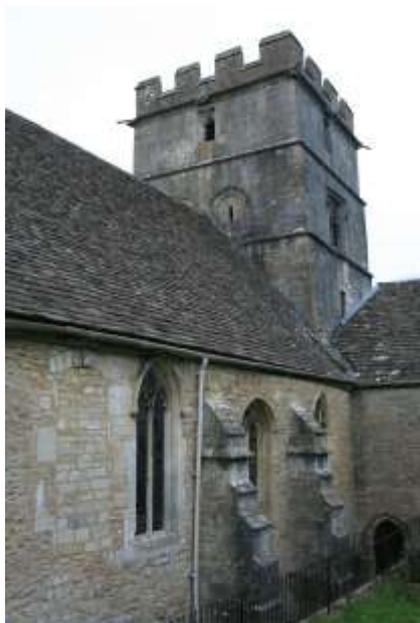
Fig 306 – west face of tower.
Note 2 Norman C12th in second
stage of tower suggesting that
west 2nd storey did not need
rebuilding in C15th/16th .

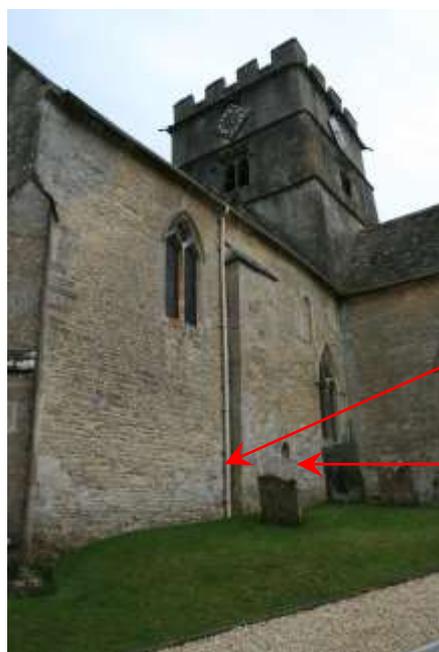
Fig 308 – North wall of chancel.
Shows successive building lifts in
the stonework with shallow
buttress. Possible crypt below?

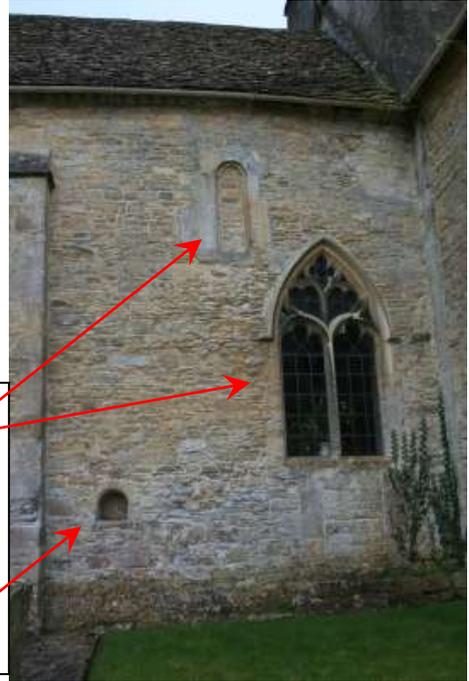
Fig 310 – east end of north chancel showing building lifts.

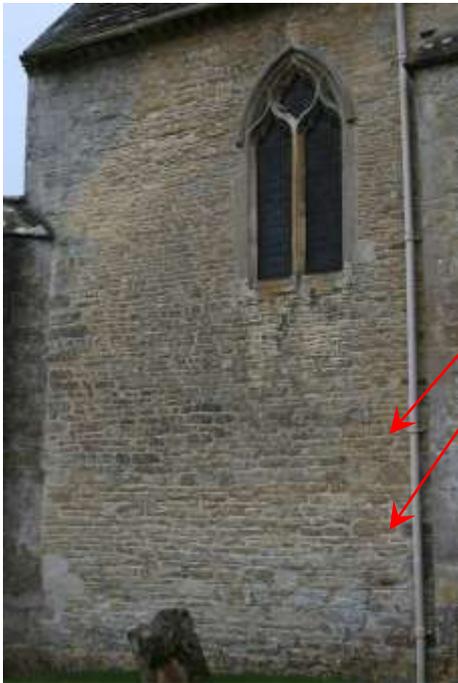
Fig 311 North wall of north transept with fine decorated window. Larger stone again to support roof.

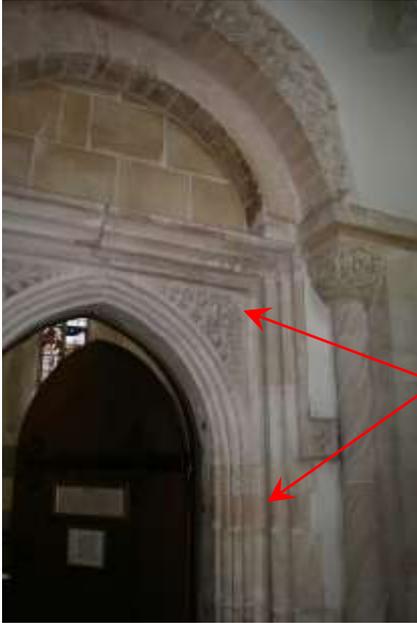
Fig 314 – North interior door;
originally exterior.
Romanesque columns &
decorated capitals with plain
round head and 15th/16thC
inset doorway.

The church retains Norman features including the door into the nave (fig 314) of the church and the chancel walls and ceiling (fig 324). I identified this not just from the wall thickness (identified in plan 203) but also from the style and shape of the windows. The door going into the nave is the original Norman arch that was created by the nuns of Caen who built the church for Queen Matilda, this is very important because the door is very high status.

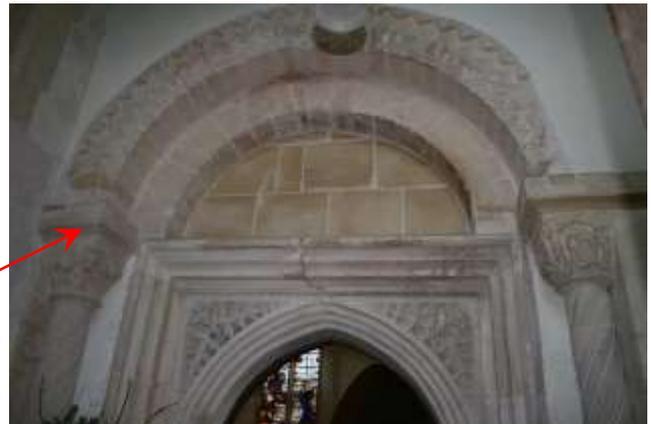
Fig 315 – Romanesque upper
doorway with 2 layers of zigzag
decoration & sculptural capitals.
Plain inner arch.

As you enter the church through the Tudor porch, you pass through the original Norman door. The door is of a high status for a church door (fig 315). This is due to Avening being owned by Bricitc who once owned the estate which was taken by William and Queen Matilda who built the church for the nuns of Caen. As she was a very important person the door way was build for her standards. Figure 316 indicates more of wealth of the village of Avening.

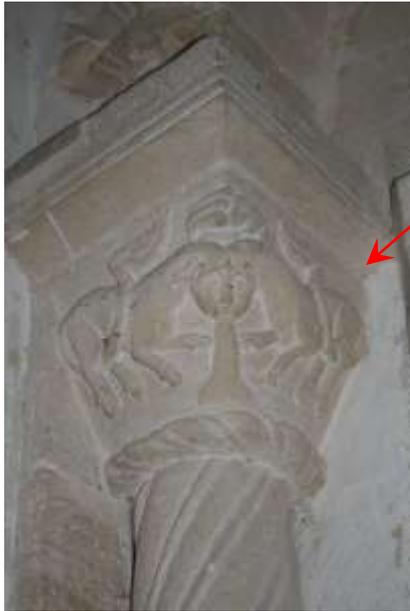
Fig 316 – Norman decorated capital of doorway. Horseman.

Fig 317 – Nave timber roof possibly C14th. Wagon roof.

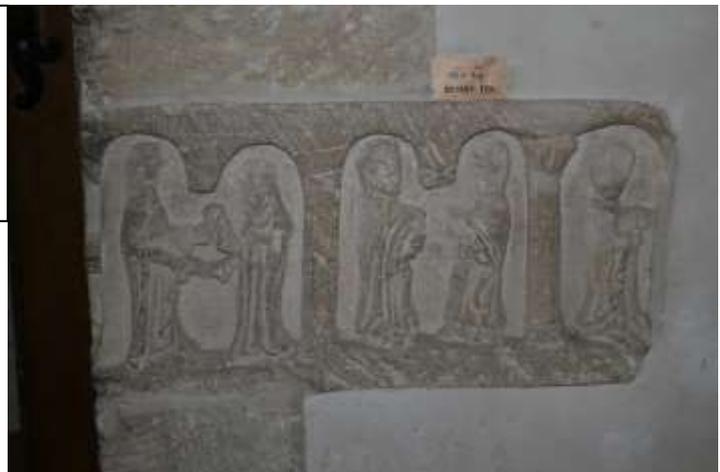
Fig 320 – Sculptural stones and some from the original Norman font, set into west wall of the north aisle.

There are also sculptural stones set into the west wall of the north aisle, which are stones from the original font bowl that was demolished and placed into the wall (fig 320), the bowl would have originally been 2 ¾ feet in length. The timber roof was put up during the 14th Century, but has since been replaced to the same style (figure 317).

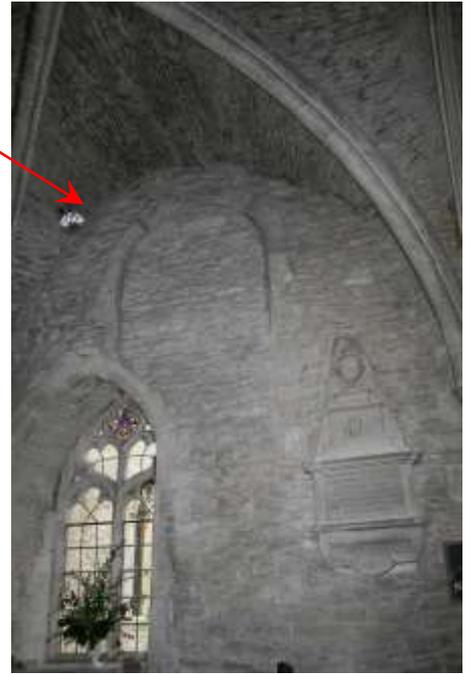
Fig 326 – West chancel arch into tower. Norman with decorated capitals on pillars.

Fig 327 – South wall of tower crossing with upper Norman window and later arch into south transept. Late C12th groined ceiling on Romanesque capitals.

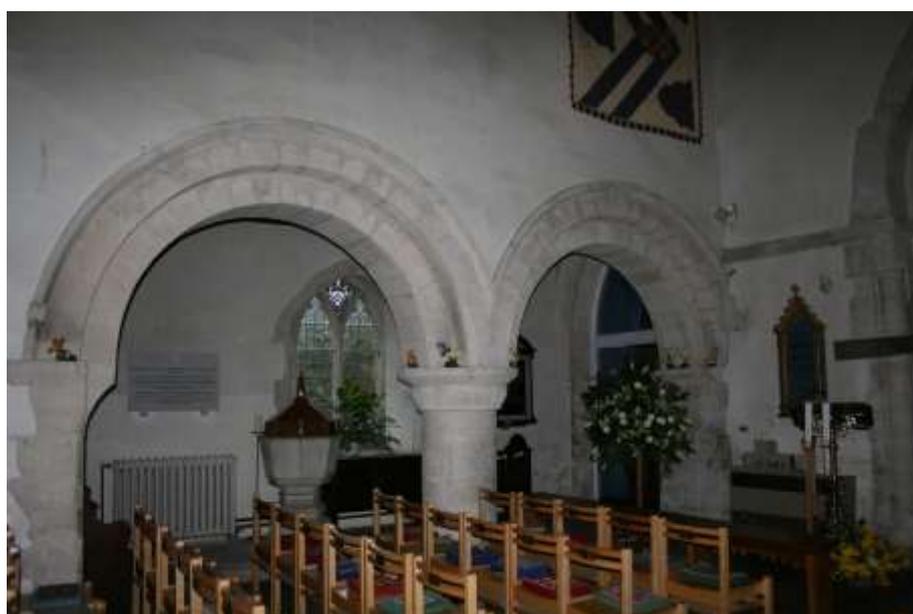
Fig 331 – Norman north aisle arcade.

Fig 3442 – filled in
perpendicular
window.

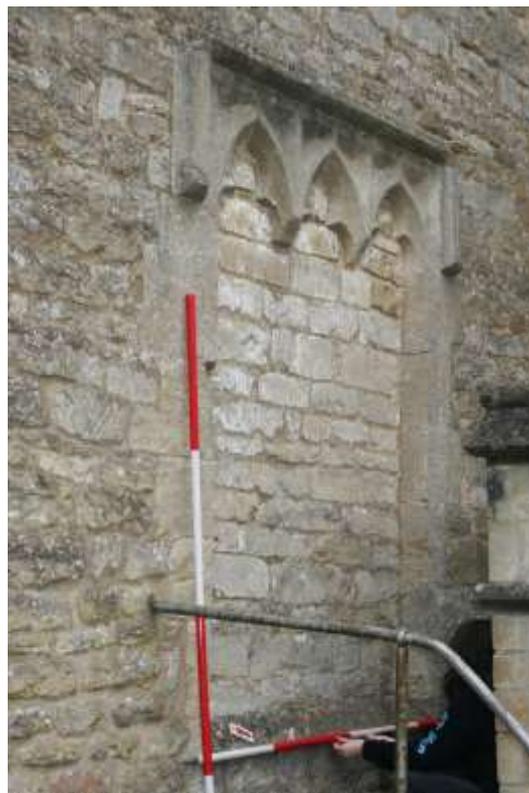
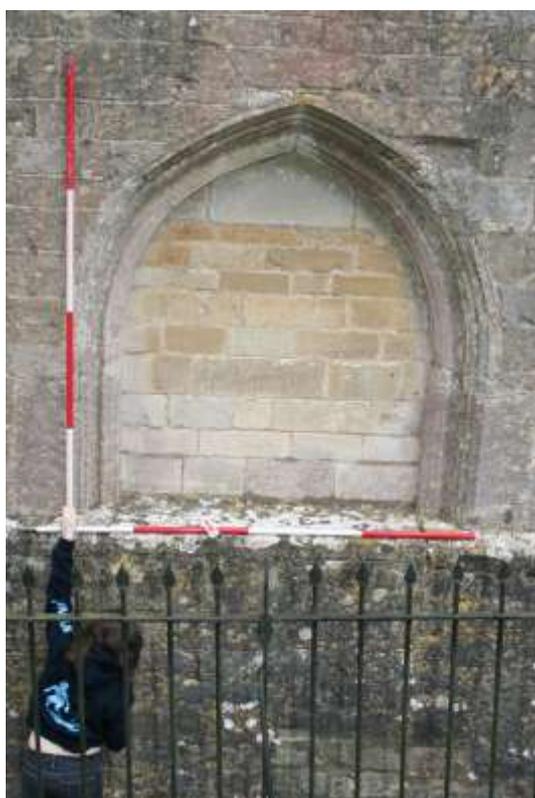
Fig 3430 – filled in door.

Fig 3405 – the filled in
door on the west wall of
the nave.

At the Western end of the Nave there is a blocked off door. There is no evidence to identify what it was used for, but there is evidence internally and externally for the door (figs 3430 and fig 3405) (Bird 1928).

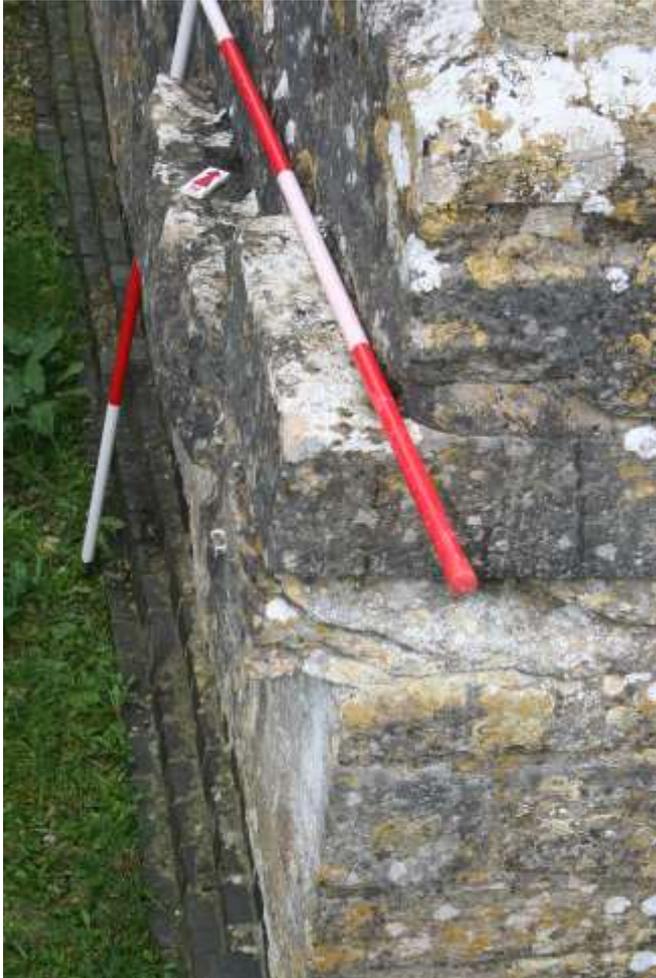
Fig 3432 – showing the kerb stones before the deepening of the trench.

The whole west wall was rebuilt in the C18th following its collapse. On the west wall there is also evidence that the trench around the outside of the church was deepened in C20th, as there are kerb stones at the original level (fig 3432). This could have been done to improve protection against dampness.

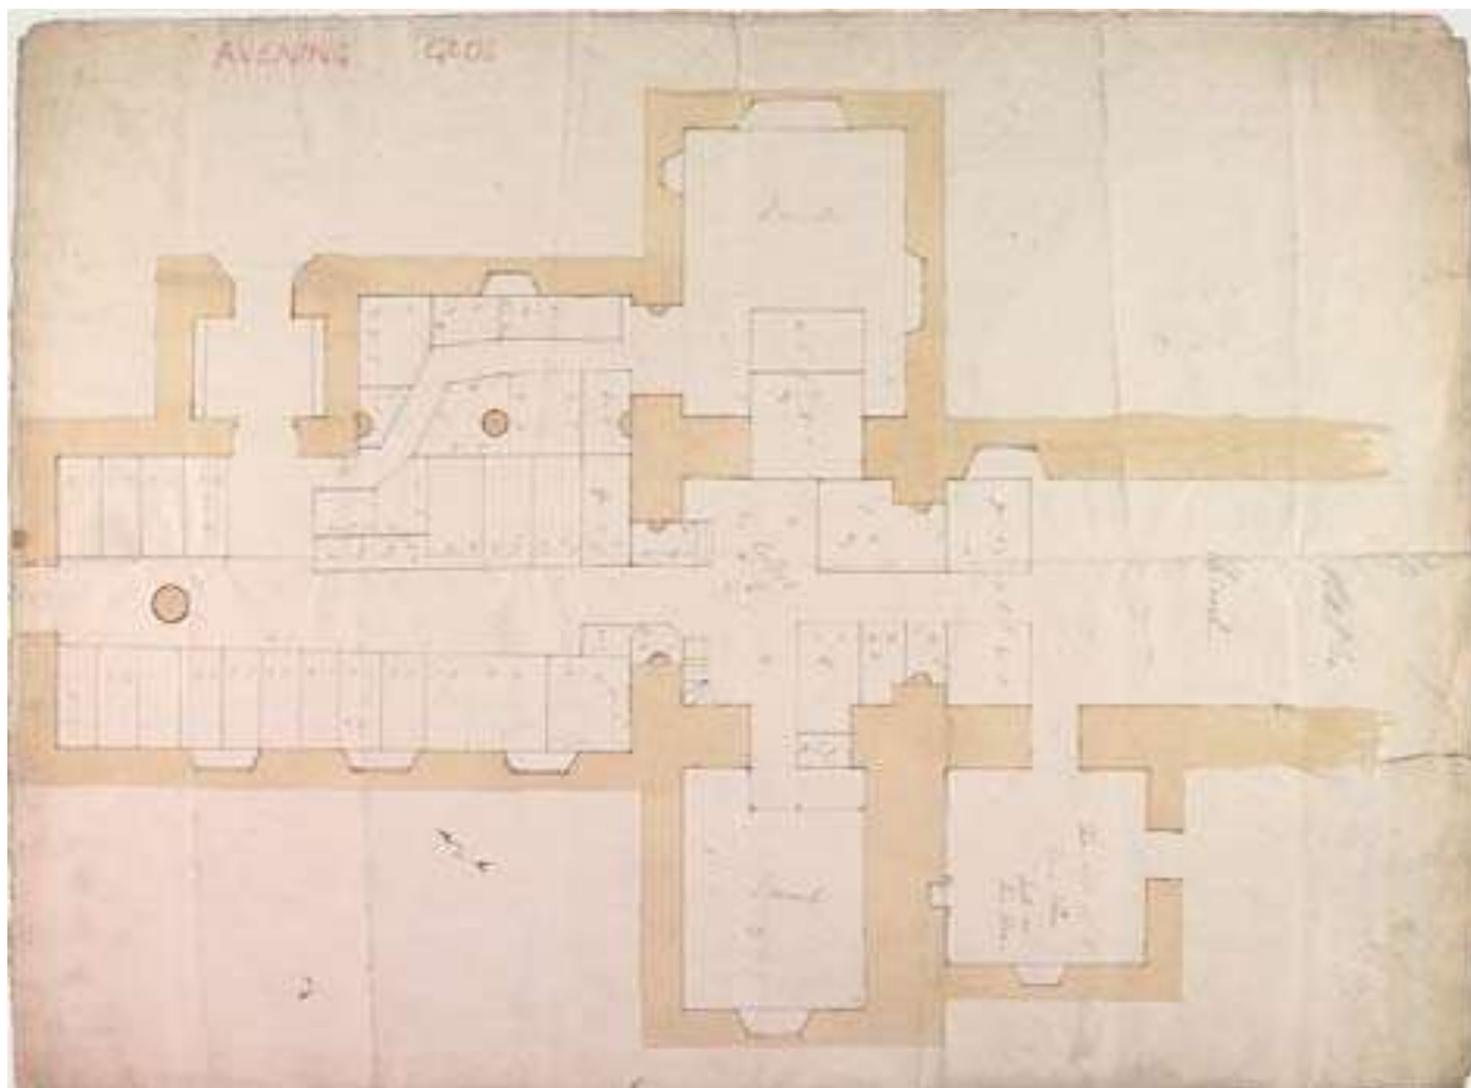
Plan 201 – Avening Holy Cross Church (1827-
1829)

Ground plan created by William MONGER
(Plan Held at Society of Antiquaries of London)
