Project Data

Site: Defence Area 58: Avening World War II Defences
Parish: Avening
County: Gloucestershire

Survey Method: Measured earthwork survey

Date of survey: 07/12/2011 and 05/01/2012

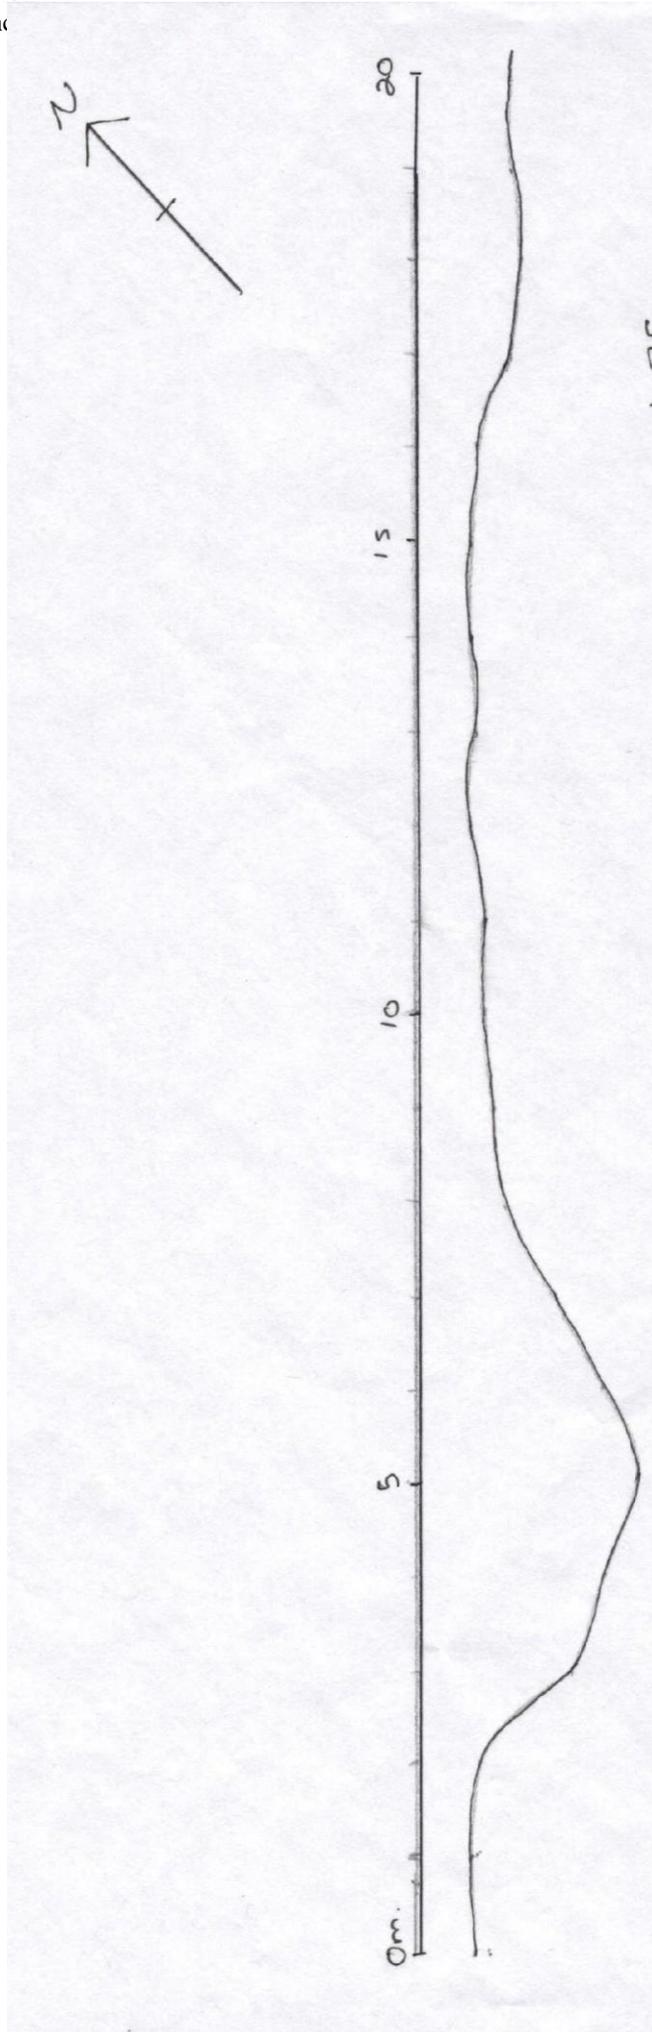
Drawing 501: Cross section of anti-tank ditch. Drawn on the best preserved section of the ditch. Drawn to a scale of 1:75.

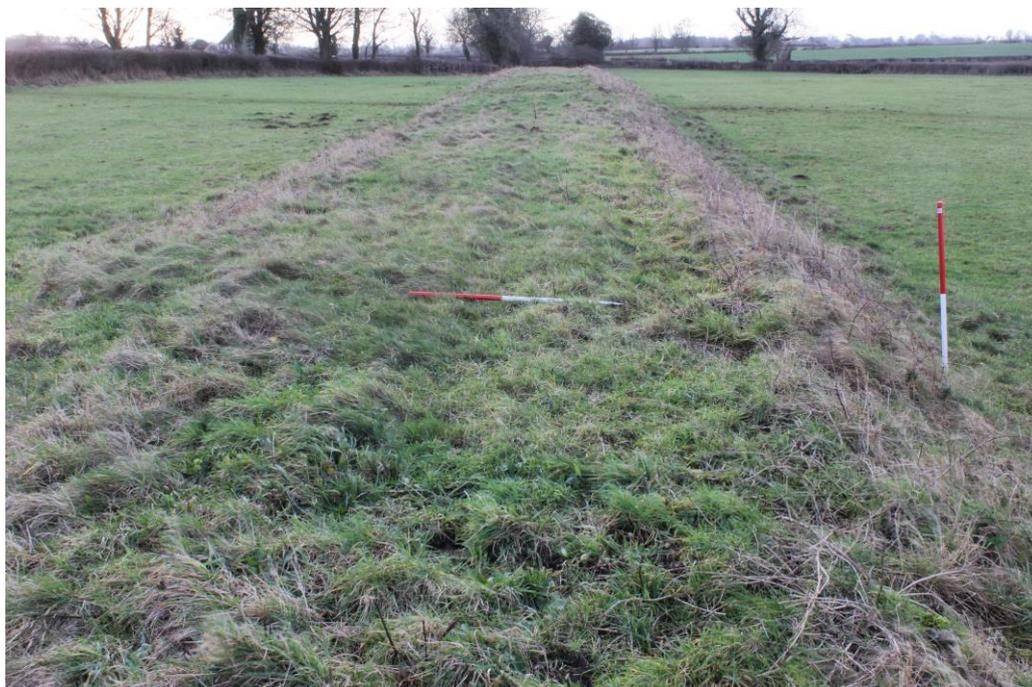
Figure 301 – Looking north east towards feature 4

Feature 3 is the remains of the anti-tank ditch. Figure 300 shows the part of the remaining bank. It is not possible to take a photo of all of this section of the ditch due to its length, but figures 301, 302 & 303 indicate some of the sections. From looking at the drawing 502 of feature 5 it looks as though instead of this being the remains of the filled in ditch, stated in both the records from Gloucestershire Archives and the Deference of Britain report, it is the remains of the bank which would have once originally accompanied the ditch. As stated in 2.4, on AP 1 there is a linear line running parallel to this feature which again suggests that feature 3 is not the remains of the in filled ditch, but that of the bank.

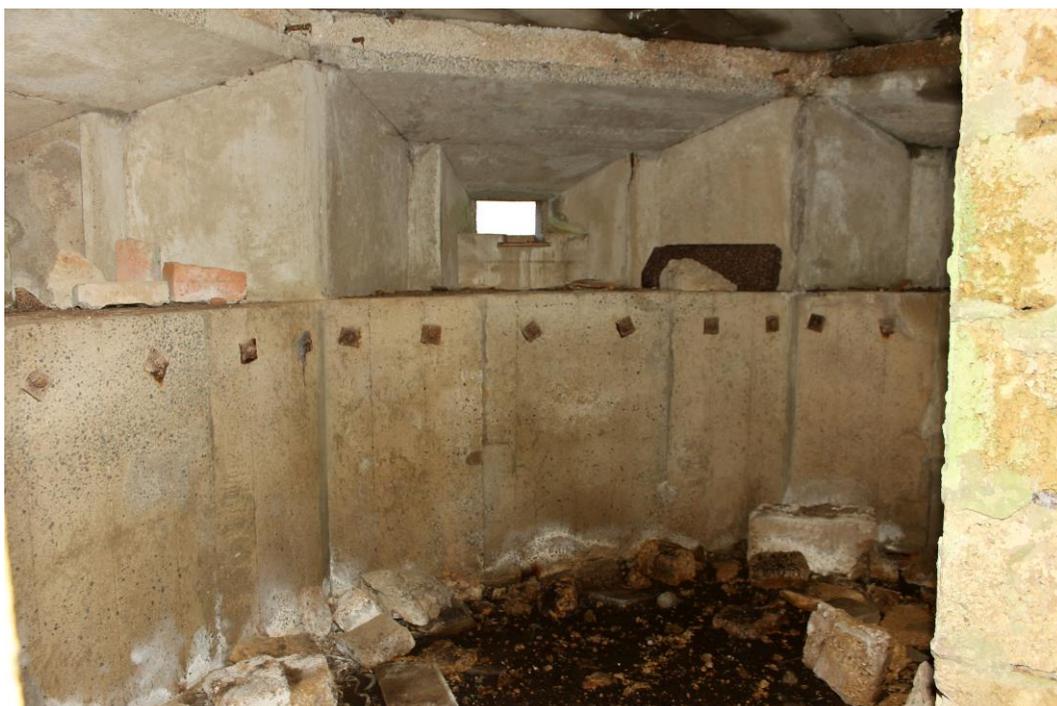
Feature 4 is a Type 24 pill box, it is located near Star Cottages on private land ownership, and is not accessible to the public. From figure 400 it is clear to see that it stands at full height. It has an attached brick entrance porch with a slab concrete roof. It is made up of prefabricated concrete panels secured by iron rods internally and externally which can be seen in figure 401. At first glance this pill box looks to be in a very good condition with a large number of the original concrete panels still in position. However, on closer inspection around the back of the pill box, the damage it has suffered is apparent. Figure 402 and 403 show that a large number of the concrete panels are missing – over time they have been used in the building of paths for Star Cottages, and for sewage pit covers. This information was given by the land owner. Internally there are calcium deposits forming stalagmites and stalactites from the leaking roof, and there is clear evidence that the pill box has been used by sheep for shelter, and other farmyard storage.

Figure 401 – internal (top) and external prefabricated concrete panels and iron bolts on feature 4

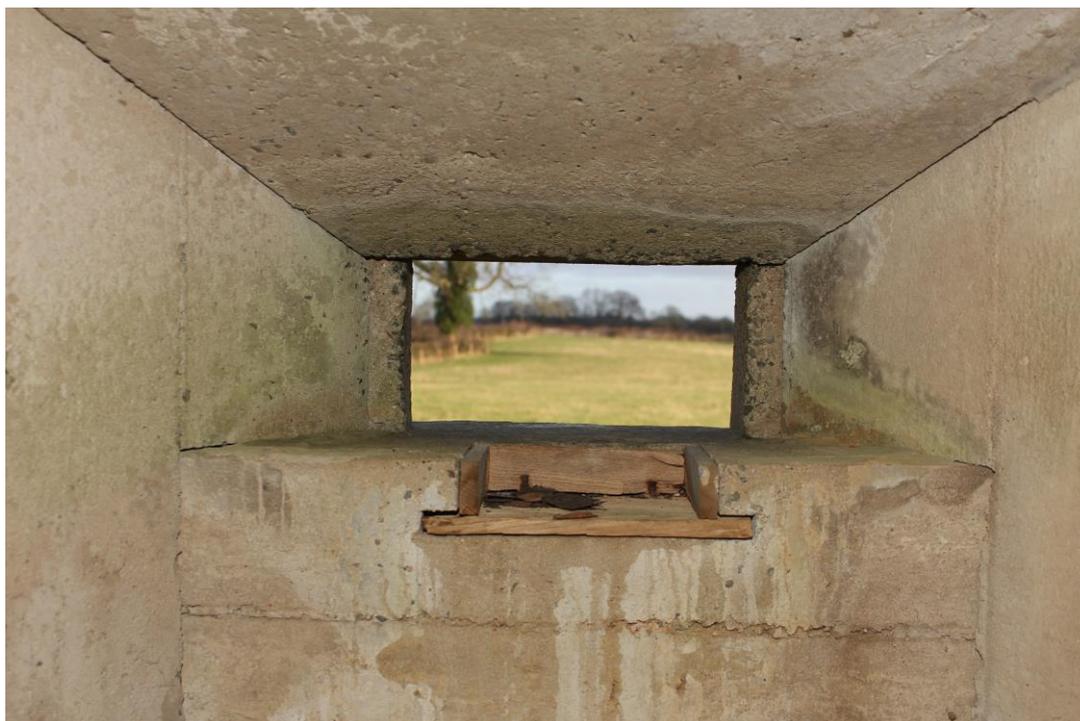
This pill box stands forward of the anti-tank ditch which would originally have run over the lane in the opposite field. This is highly unusual. Facing East, this pill box had a clear view of the surrounding land space - this can be seen in figure 404.

Figure 404 – view from the pill box, looking north

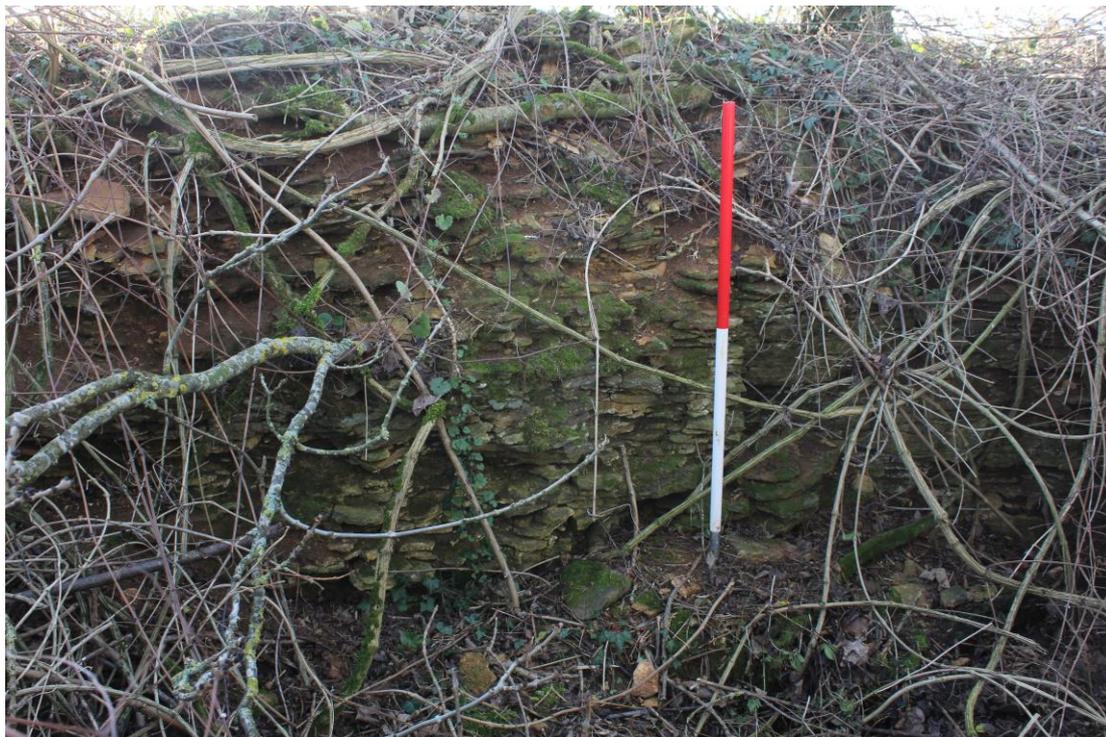
Feature 5 is part of the remaining anti-tank ditch that ran across the land joining up the pill boxes. This section of the ditch still remains unfilled. Figure 500 indicates some of the length of the ditch. Drawing 500 (first fold out) is the earthwork survey that was carried out. It is not the full length of the remaining ditch, as the dense surrounding woodland and built up rubbish (figure 501) in the ditch make it impossible to draw the whole distance. It is unclear why this particular section of the ditch remained unfilled, but from local knowledge, when it fell out of use, it was used for silage storage by Star Farm. It is now filling with rubbish and undergrowth. An entrance way has been cut into the ditch, point A on Drawing 500. This was built by the farmer to make it easier to dump rubbish in it. During and after World War II, the anti-tank ditches filled up with water due to a lack of drainage, and were used to teach the local children how to swim. Drawing 501 is a cross section of the anti-tank ditch. From this drawing it is clear to see that the ditch and accompanying bank can still be made out. Figure 502 shows the dry stone walls which can be traced along both sides of the anti-tank ditch.

Figure 502 – photo indicating the wall of the anti-tank ditch

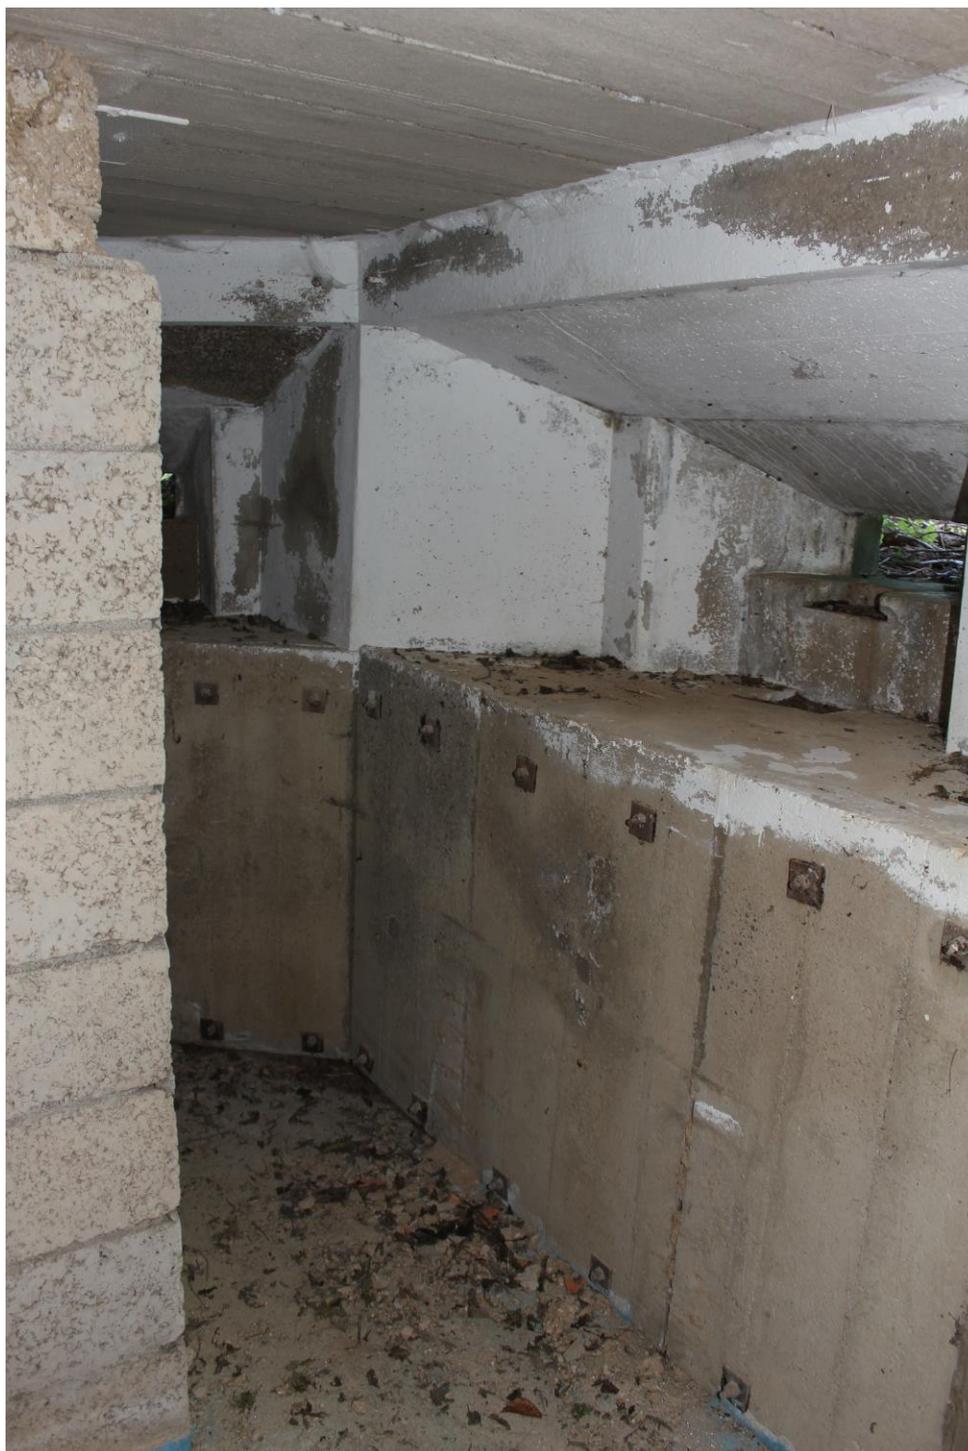
Figure 601 – interior prefabricated concrete panels and iron bolts.
